Common causes for Compressor Clutch Failures

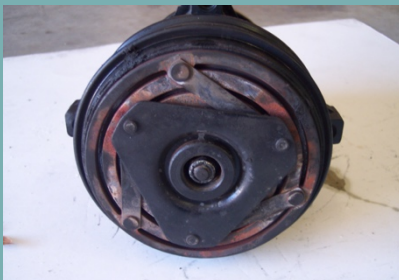
Here are a couple of pictures that relate to clutch failure. The one on the left shows a clutch which has been overheated due to slippage. Notice the reddish brown discoloration on sections of the front hub. This is where heat caused the paint to blister and discolor.

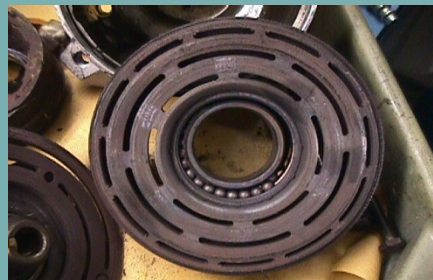
The picture on the right shows what the surface of the pulley looks like that drives the front hub after it has experienced slippage. It got so hot that the grease in the bearing melted and leaked out and then the bearing failed. You do not always have bearing failure when this occurs. This is not actually from the compressor on the left but if you removed the front hub it would look similar.
